DEPARTMENT OF THE ARMY  
UNITED STATES ARMY AVIATION TEST BOARD  
Fort Rucker, Alabama 36360

SUBJECT: Letter Report, (6) Product-Improvement Test of Component  
TBO Extension, UH-1( ) Helicopter, RDT&E Project No.  
(16) USATECOM Project No 4-5-0101-03

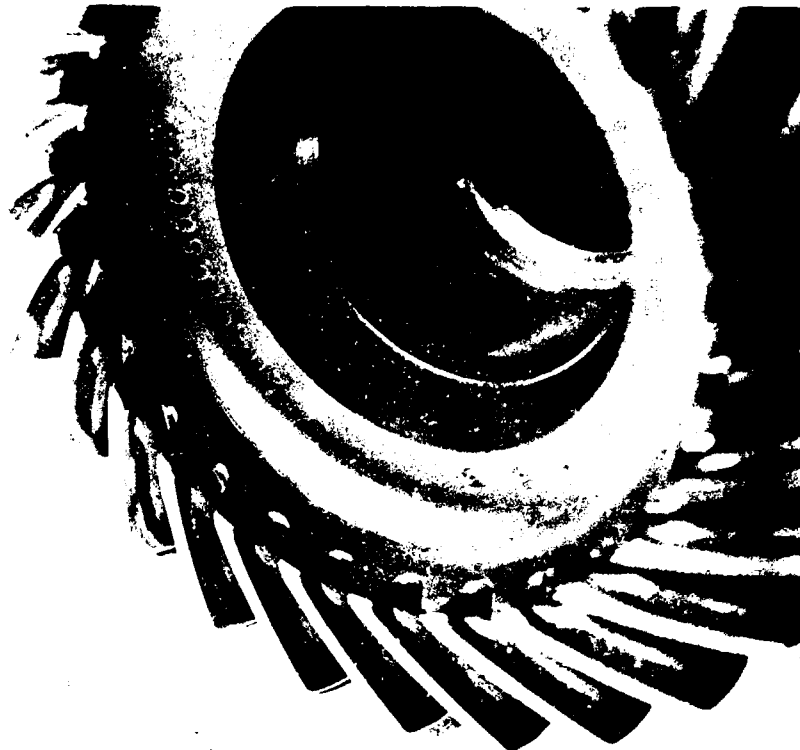
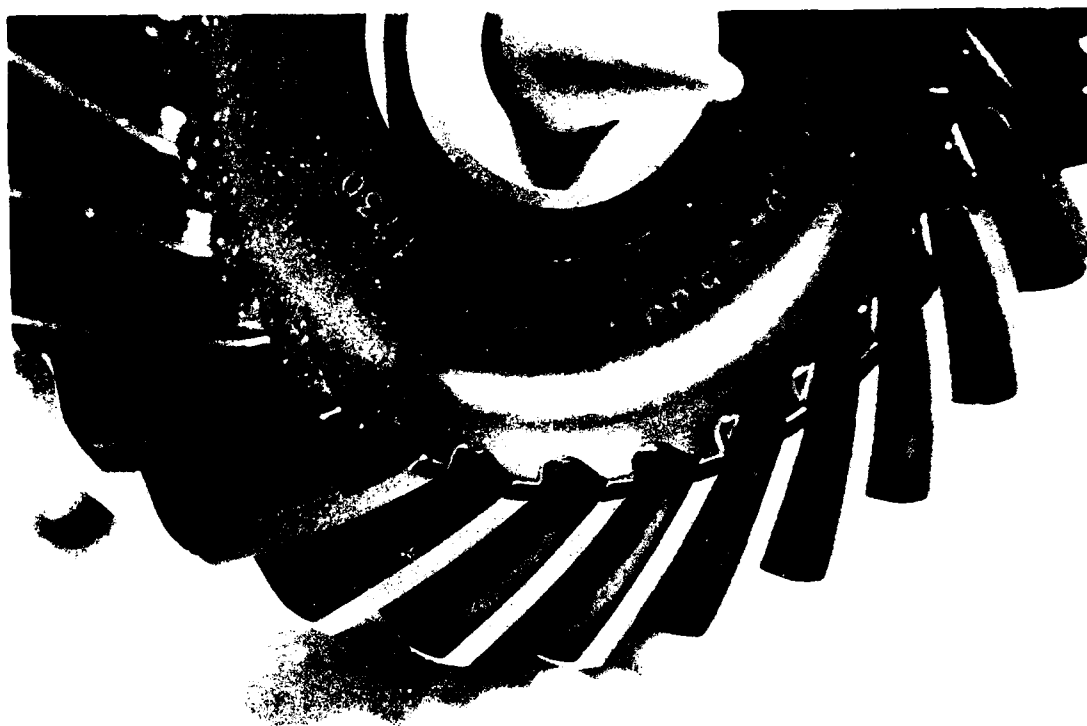
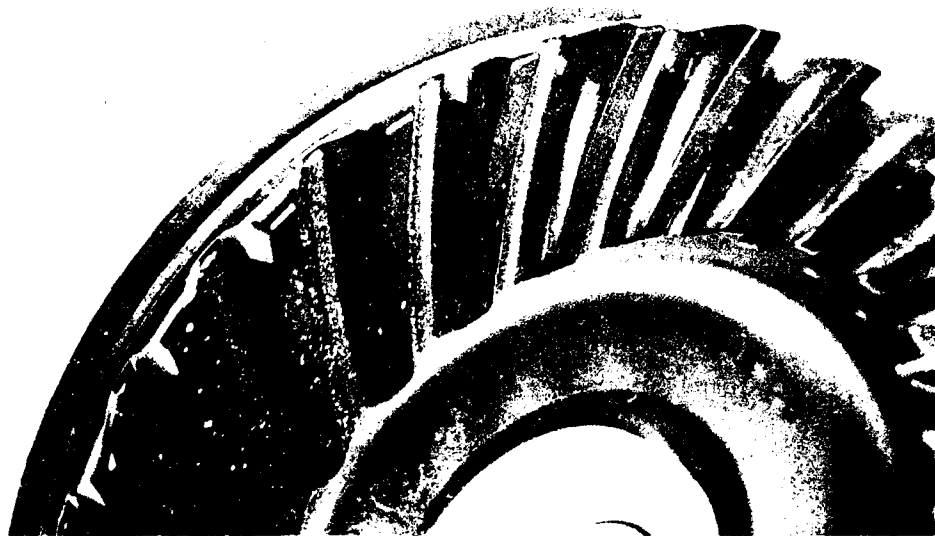
Figure 13. Convex side of input gear teeth.  
(42-degree gearbox, S/N B13-1431, 1100.0  
operating hours.)

Figure 14. Concave side of input gear teeth.  
(42-degree gearbox, S/N B13-1431, 1100.0  
operating hours.)

Figure 15. Concave side of output gear teeth.  
(42-degree gearbox, S/N B13-1431, 1100.0  
operating hours.)

Figure 16. Convex side of output gear teeth.  
(42-degree gearbox, S/N B13-1431, 1100.0  
operating hours.)

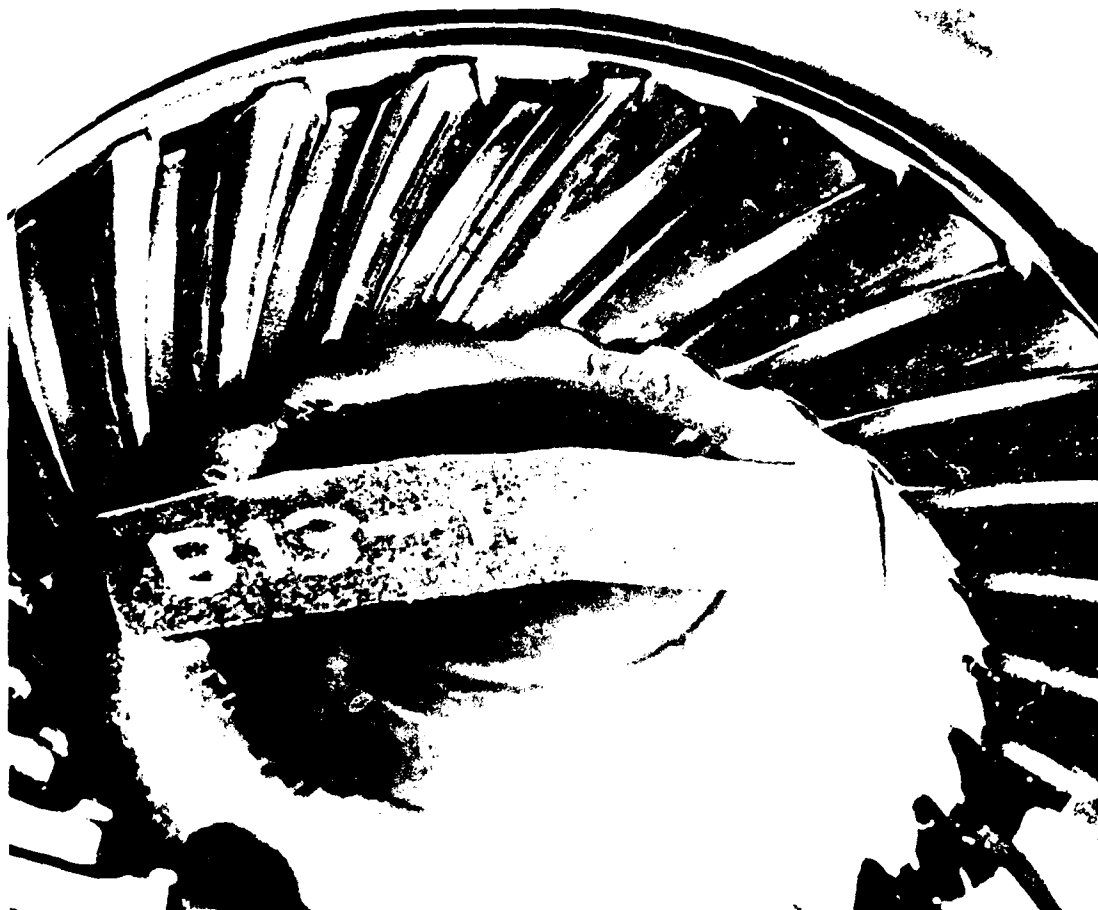
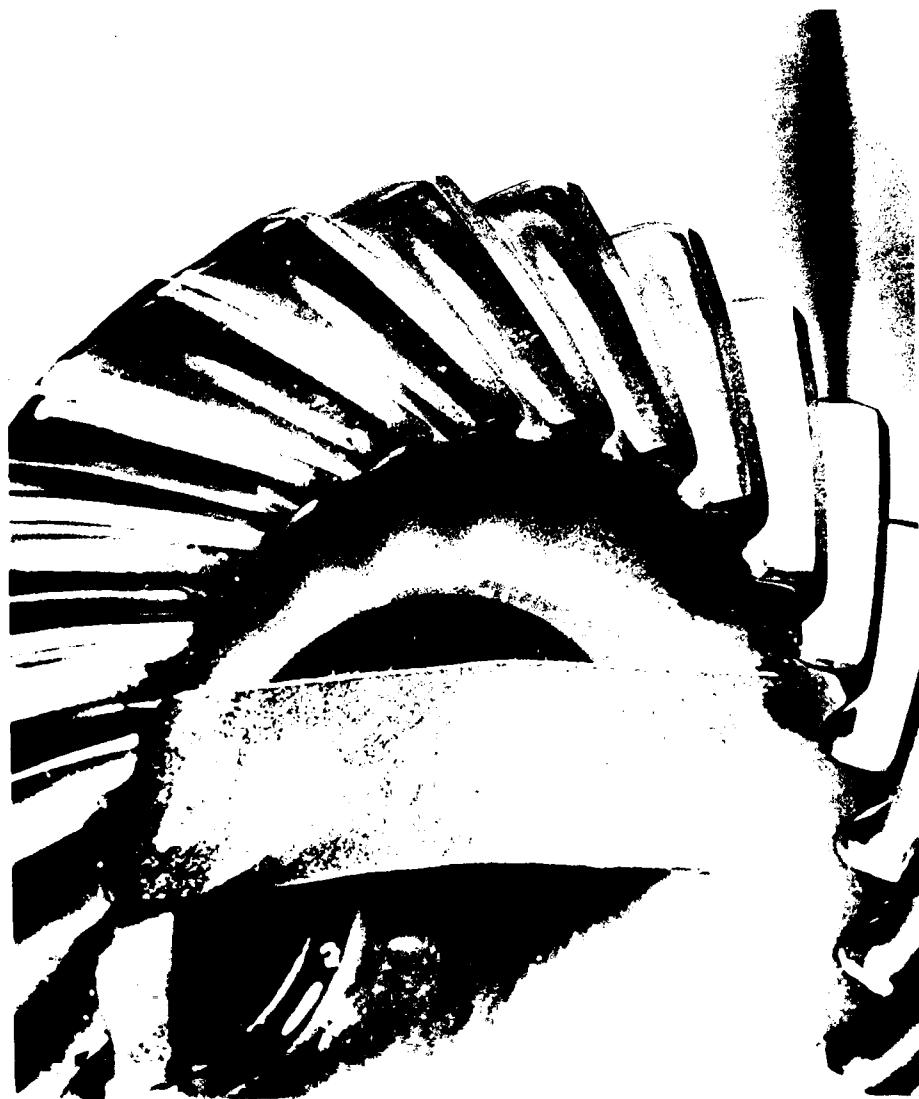
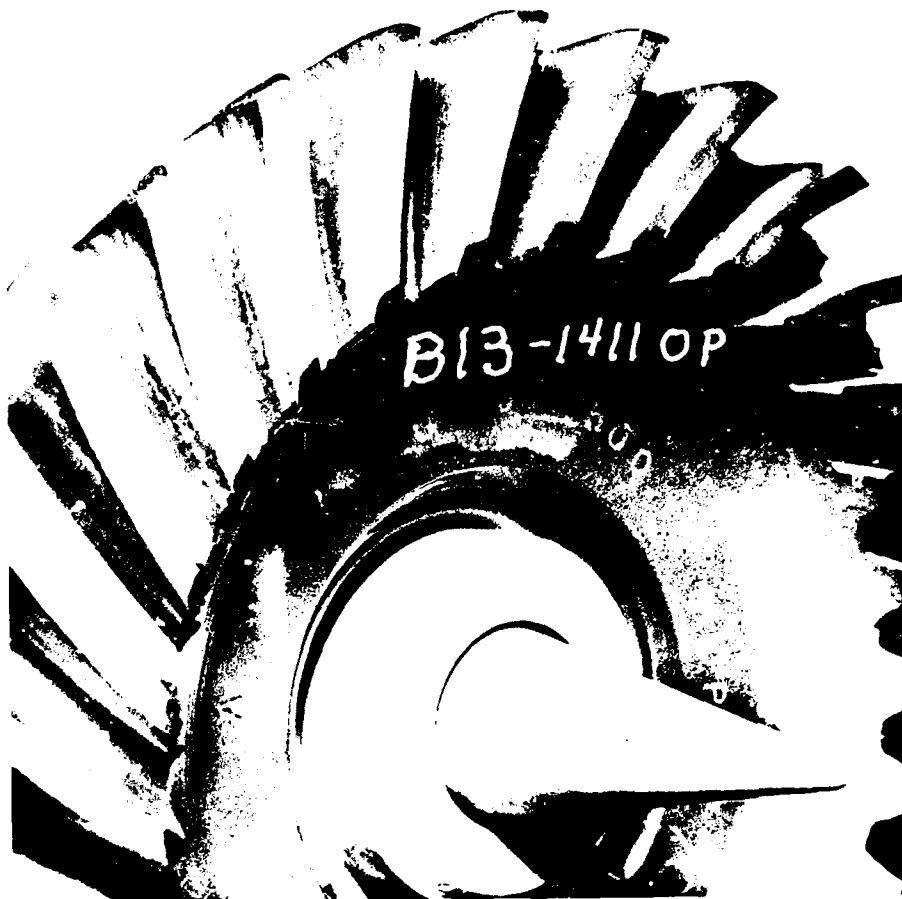
Figure 18. Convex side of input gear teeth.  
(42-degree gearbox, S/N B13-1411, 1099.0  
operating hours.)

Figure 12. Concave side of input gear teeth.  
(42 degree gearbox, S/N B13-1411, 1099.0  
operating hours.)

Figure 20. Concave side of output gear teeth.  
(42-degree gearbox, S/N B13-1411, 1099.0  
operating hours.)

Figure 21. Convex side of output gear teeth.  
(42-degree gearbox, S/N B13-1411, 1099.0  
operating hours.)

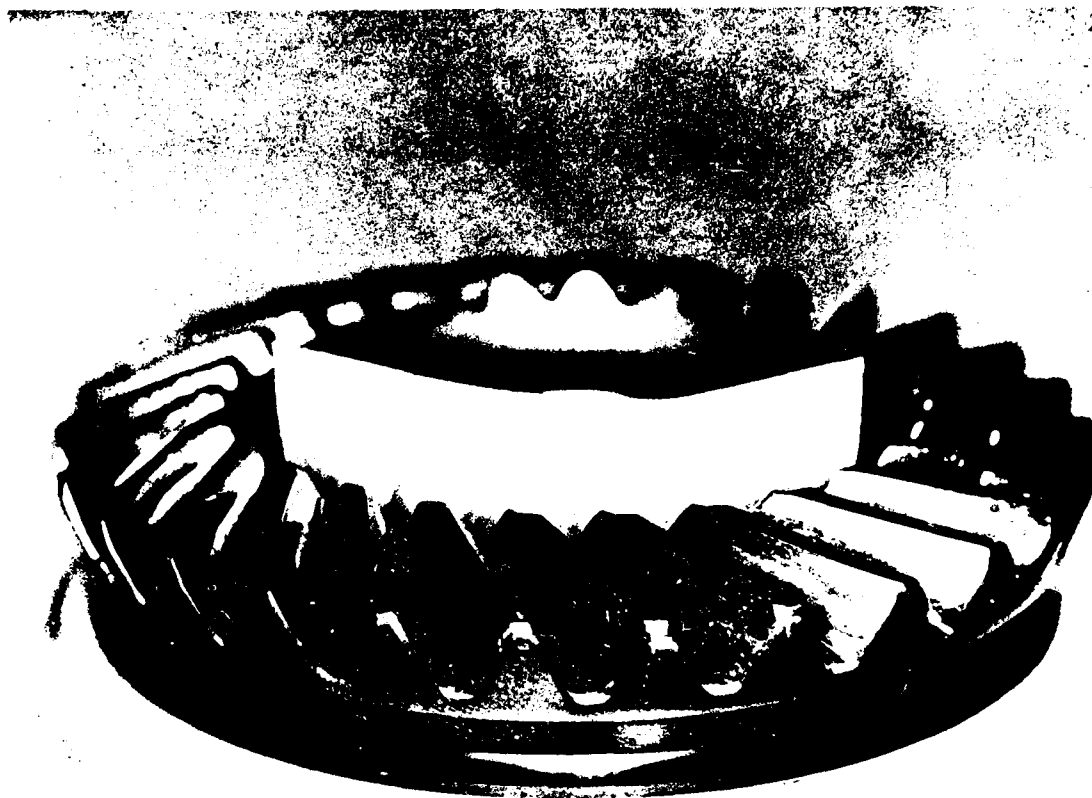
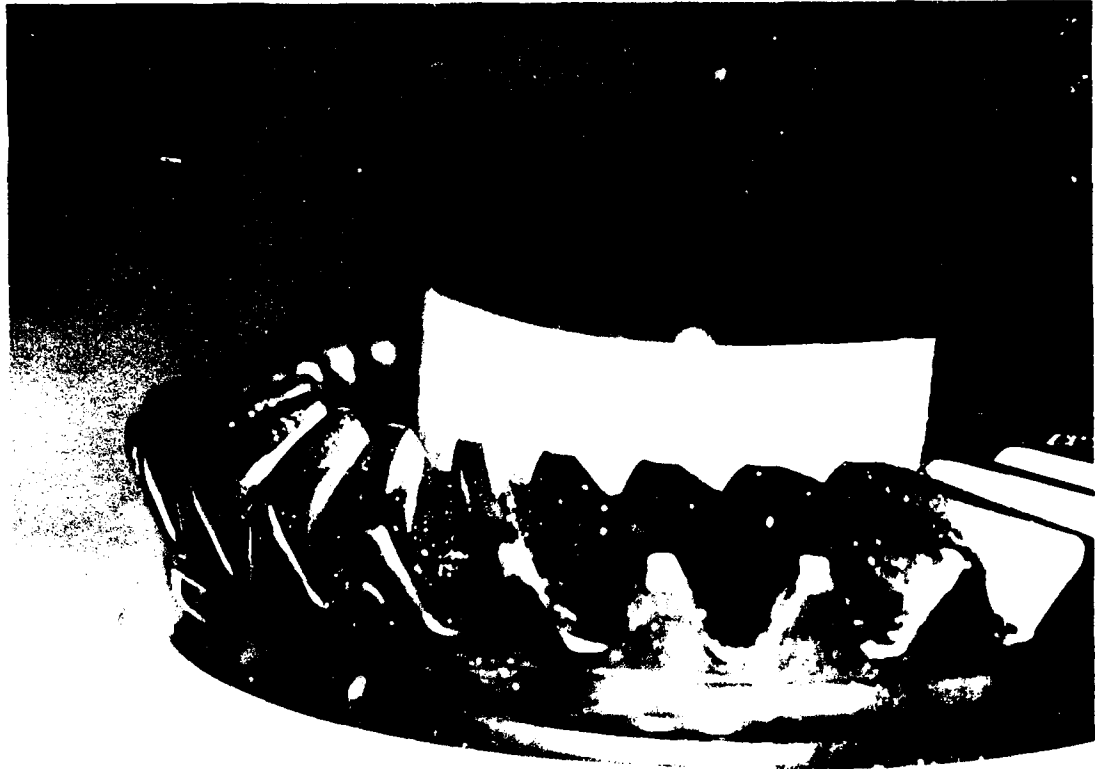
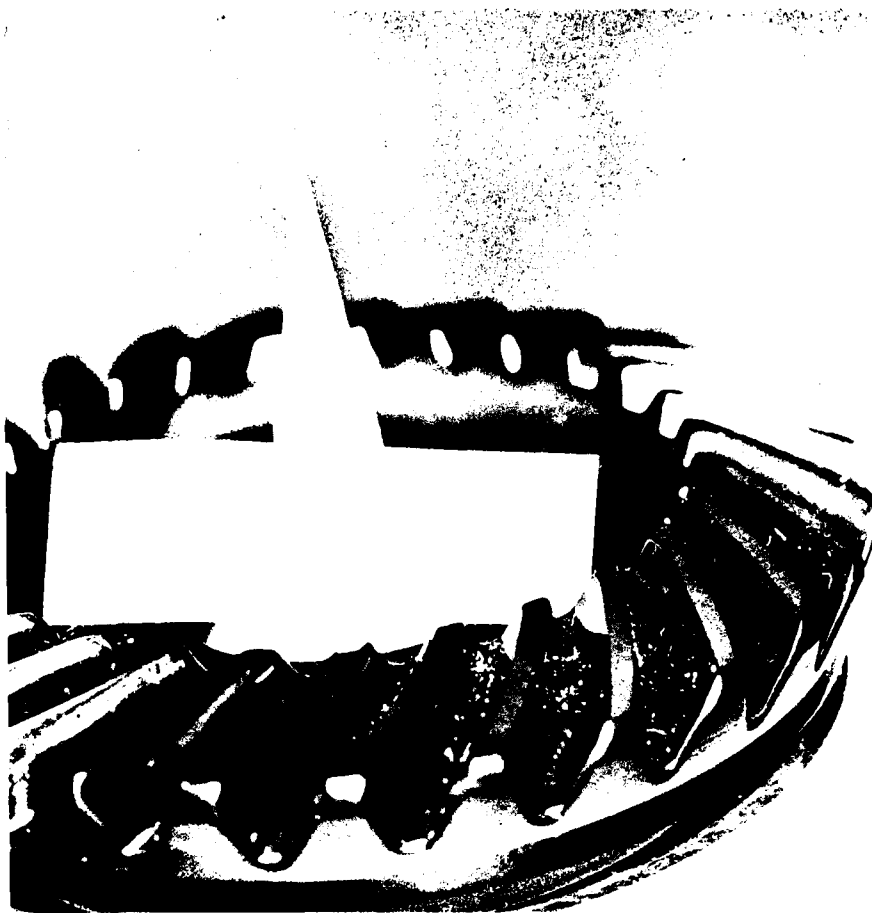
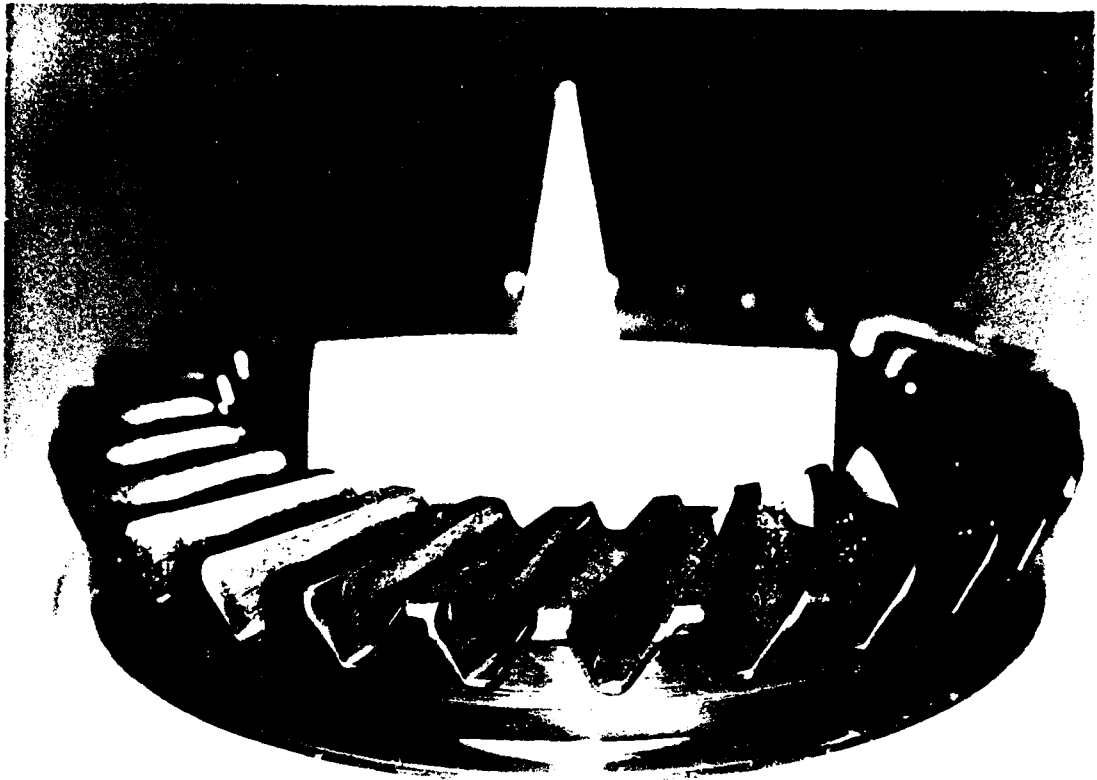
Figure 23. Convex side of input gear teeth.  
(42-degree gearbox, S/N B13-1127, 1089.0  
operating hours.)

Figure 24. Concave side of input gear teeth.  
(42-degree gearbox, S/N B13-1127, 1089.0  
operating hours.)

Figure 25. Concave side of output gear teeth.  
(42-degree gearbox, S/N B13-1127, 1089.0  
operating hours.)

Figure 26. Convex side of output gear teeth.  
(42-degree gearbox, S/N B13-1127, 1089.0  
operating hours.)

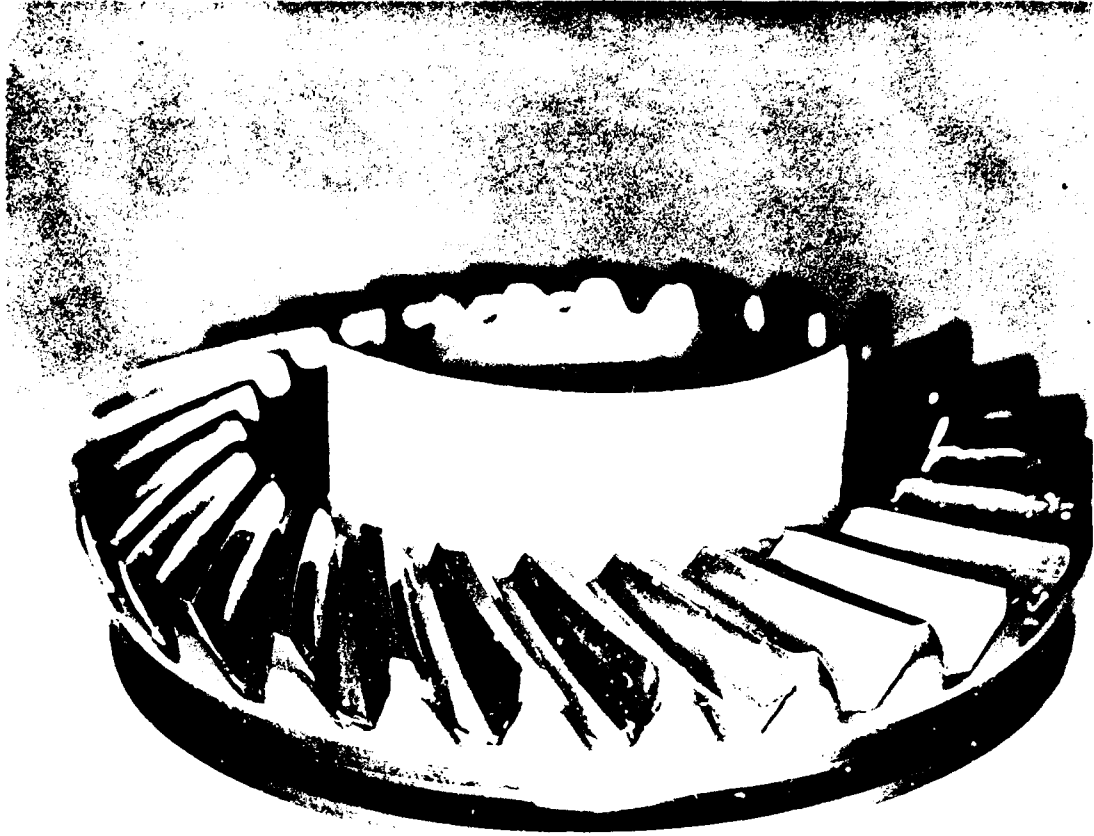
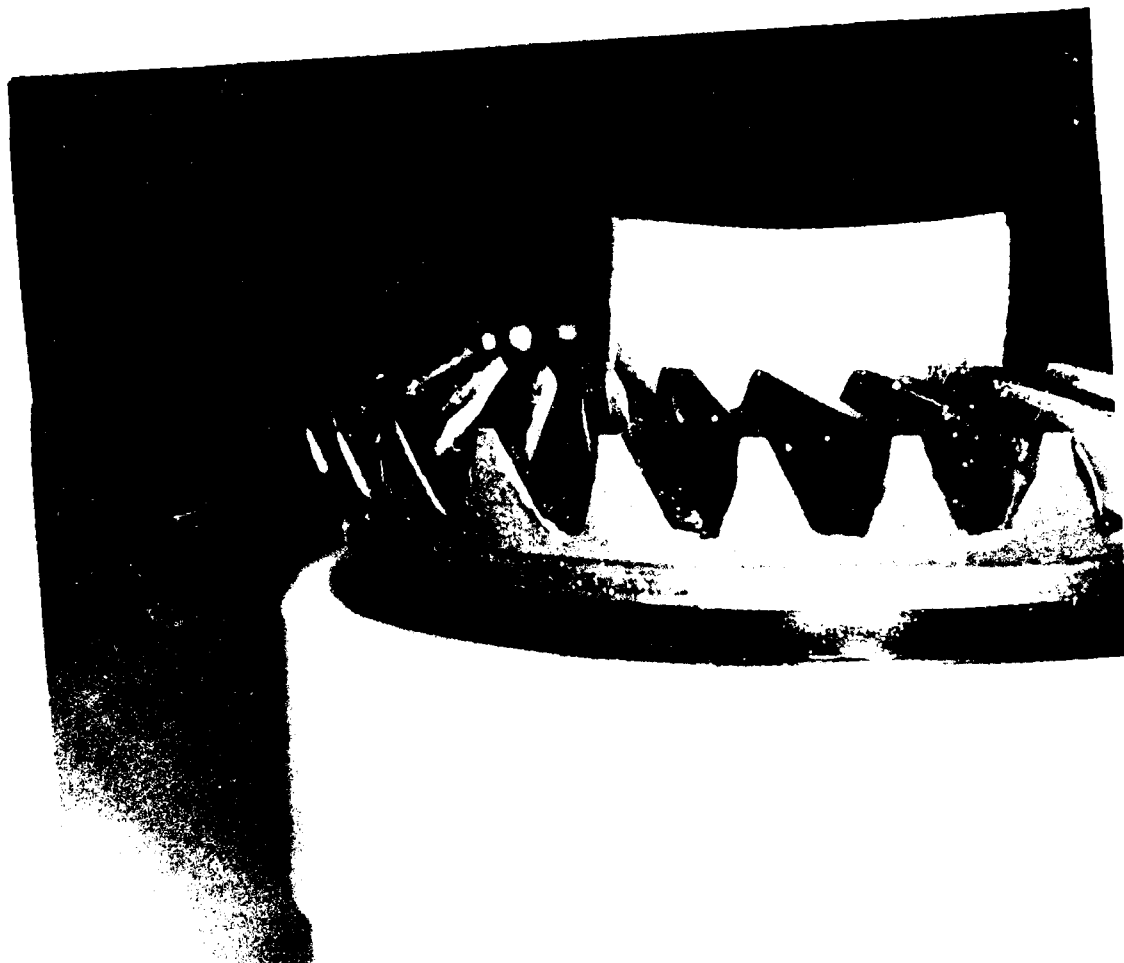
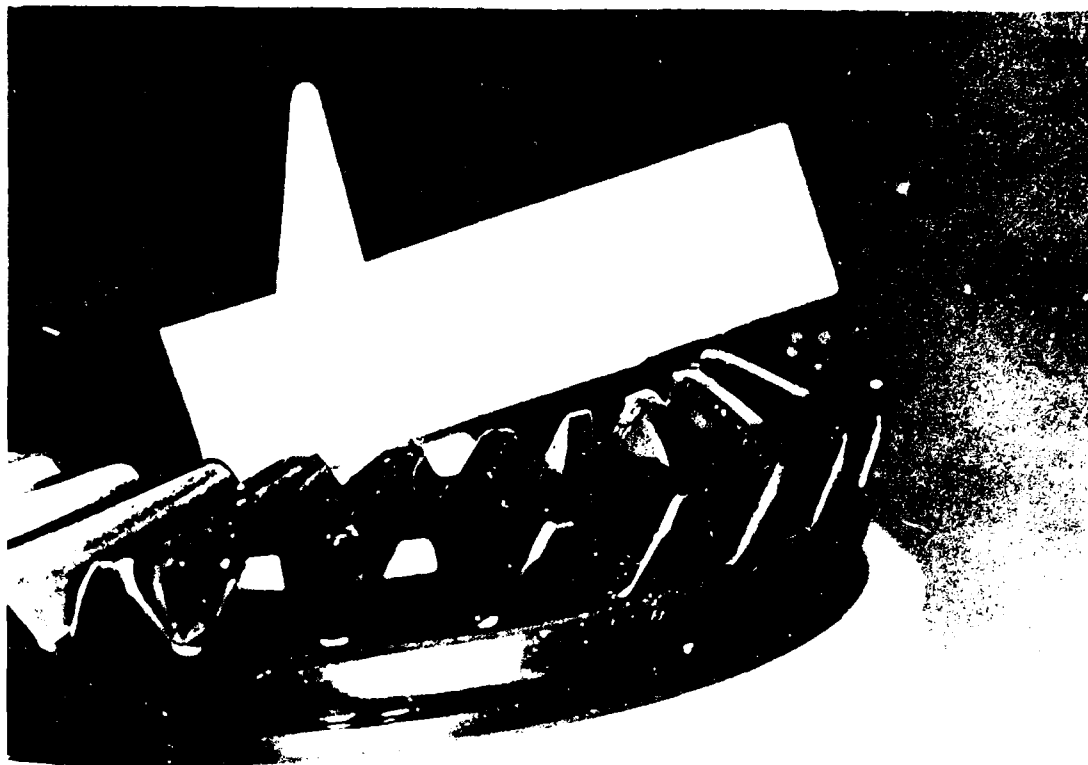
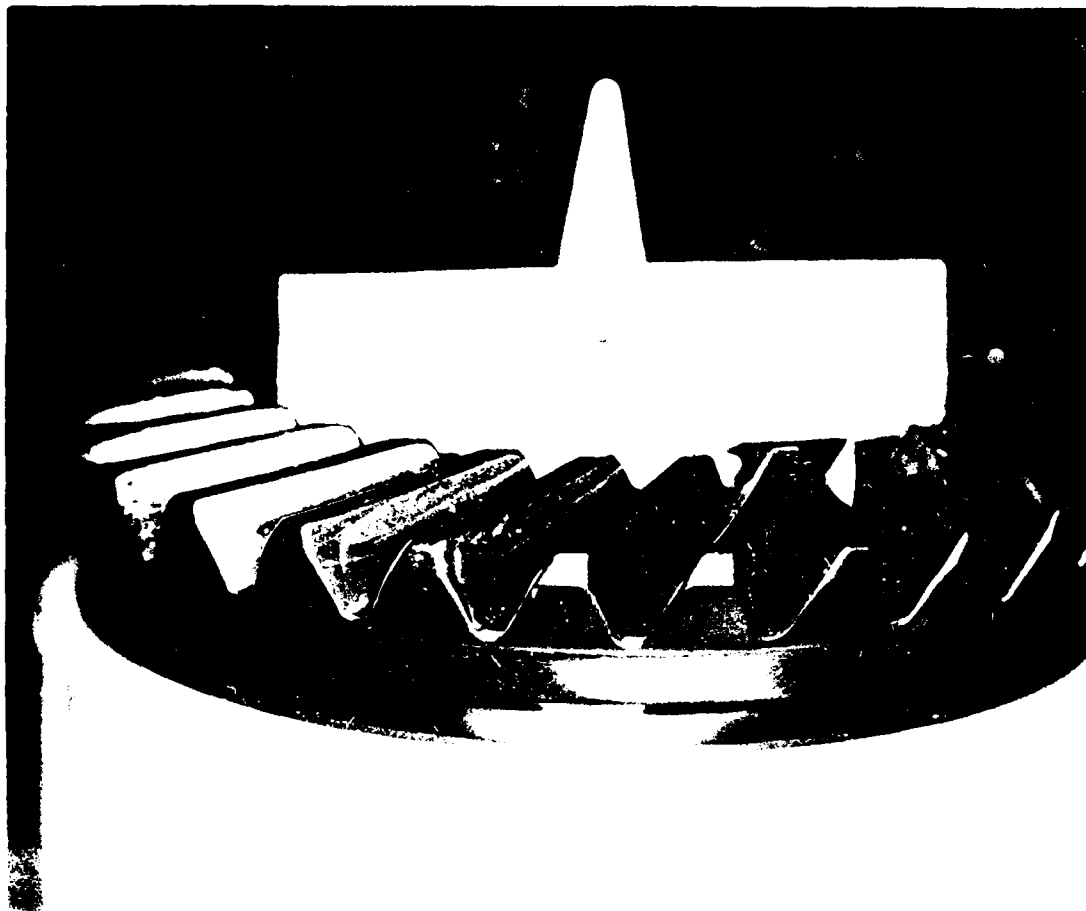
d. S/N B13-1371. This gearbox had operated 1081.0 hours in RVN. Figures 30, 31, 32, and 33 show the gears as received. The bearings of both quills rotated smoothly. The wear and backlash patterns that were present on the teeth at 1081.0 hours are displayed in figure 34. One input gear tooth had a pit on the top near the convex edge approximately 0.062 inch in diameter. The gearbox was considered serviceable for testing and accumulated 1181.4 hours prior to the next inspection. At the 1181.4-hour inspection, the bearings in both quills turned smoothly. No change in wear or backlash patterns on the output gear teeth had occurred since the 1081-hour inspection; however, some change had occurred to the input gear teeth (figure 35). The pit that was present on the top of one of the input gear teeth at the 1081-hour inspection was no longer present. The gearbox was considered serviceable for further testing. After accumulating 1309.9 hours, the gearbox was again inspected. No change in wear or backlash patterns had occurred, and no discrepancies were observed. Both quills were somewhat tighter in rotation than before; however, no roughness was present and the gearbox was considered serviceable.

Figure 30. Convex side of input gear teeth.  
(42-degree gearbox, S/N B13-1371, 1081.0  
operating hours.)

Figure 31. Concave side of input gear teeth.  
(42-degree gearbox, S/N B13-1371, 1081.0  
operating hours.)

Figure 32. Concave side of output gear teeth.  
(42-degree gearbox, S/N B13-1371, 1081.0  
operating hours.)

Figure 33. Convex side of output gear teeth  
(42-degree gearbox, S/N B13-1371, 1081.0  
operating hours.)

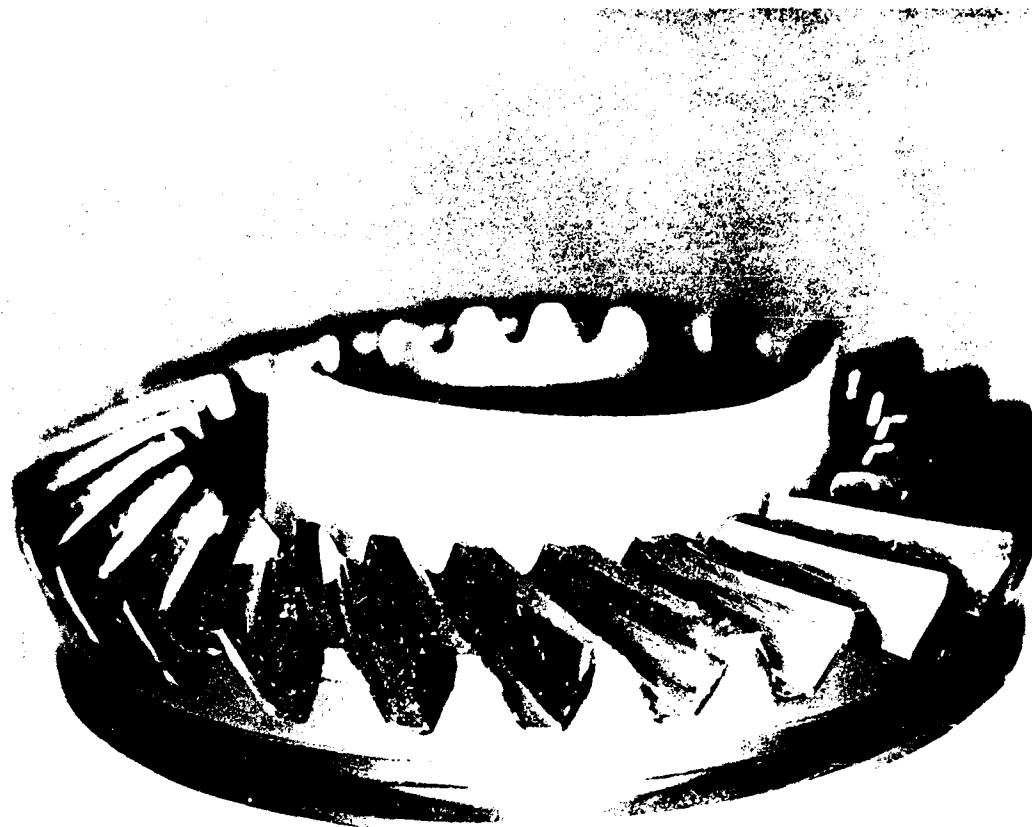
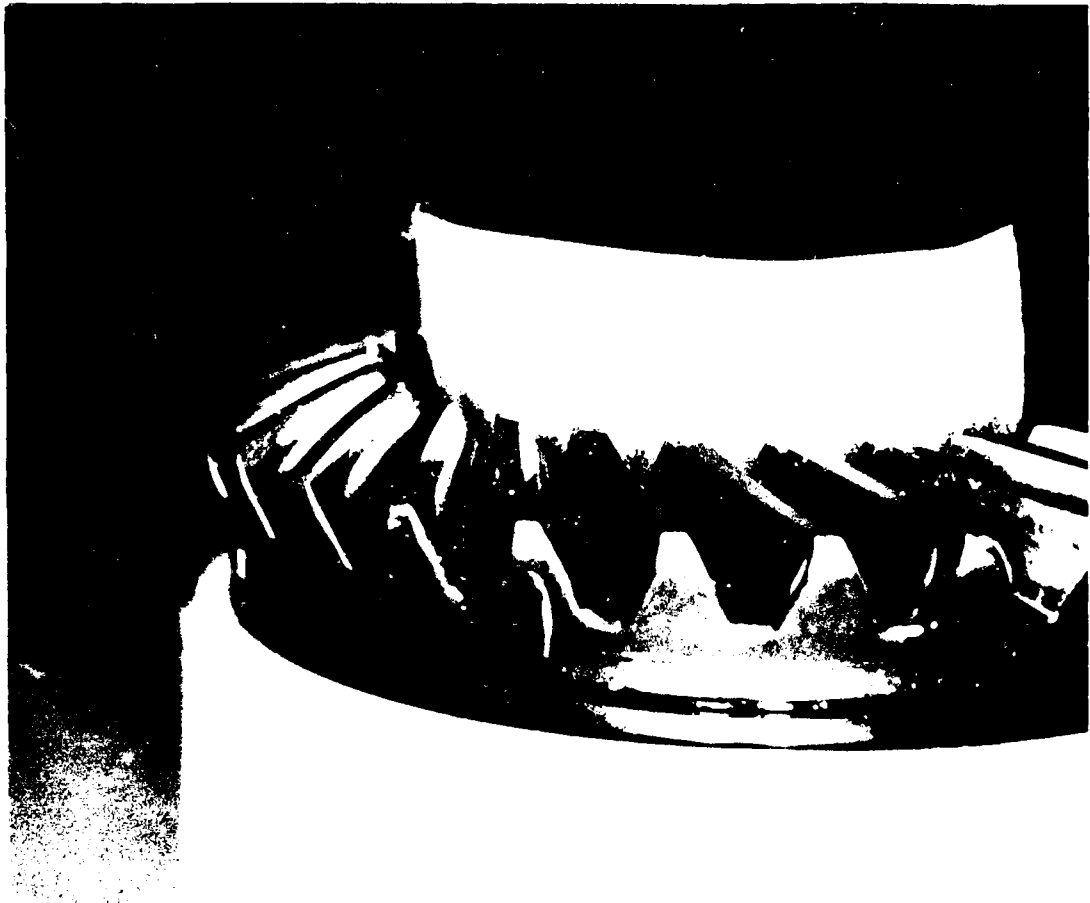
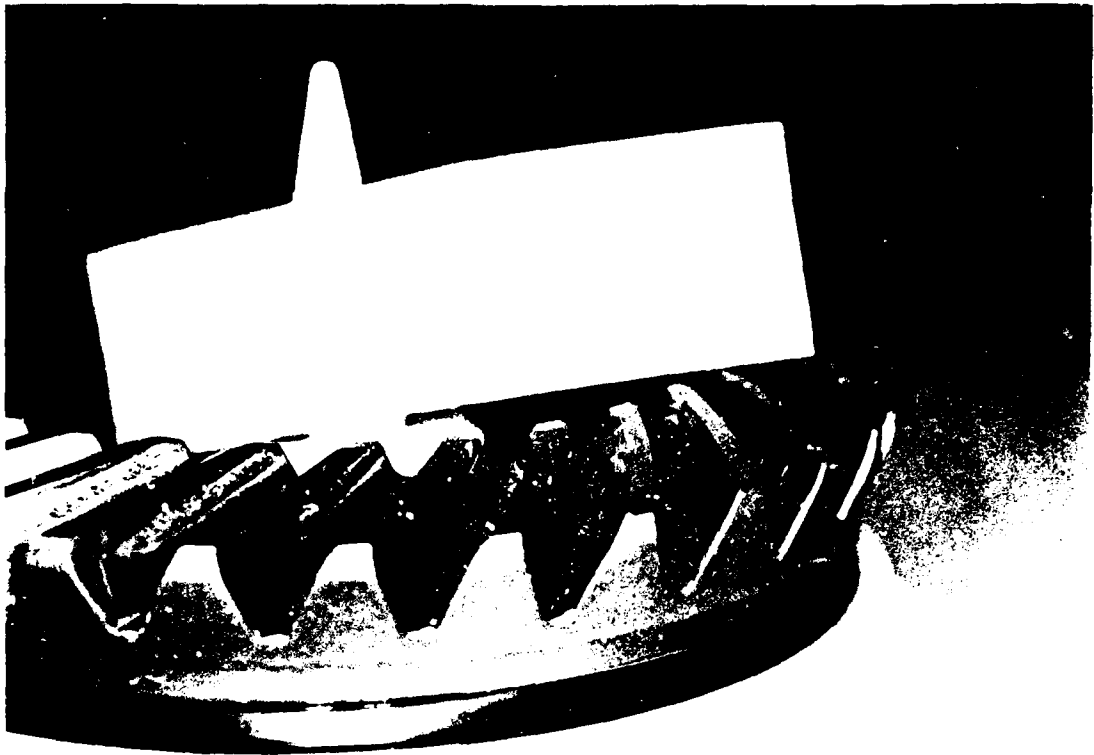
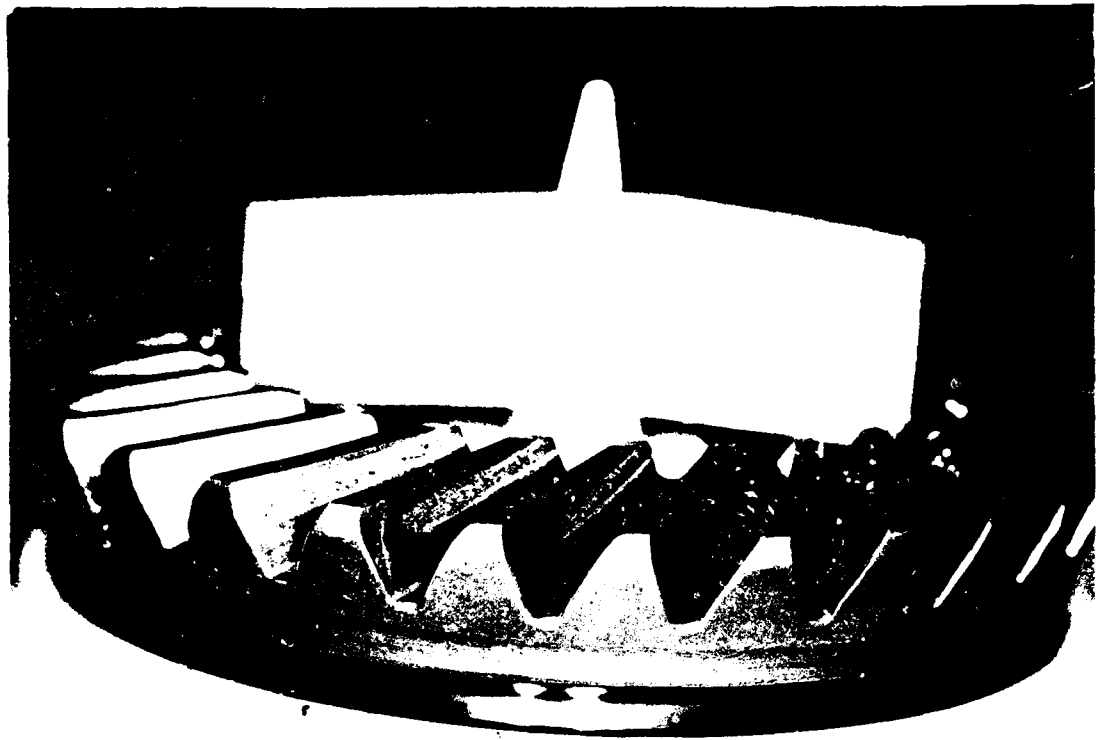
e. S/N B13-1277. This gearbox had operated 1071.0 hours in RVN. Figures 36, 37, 38, and 39 show the gear teeth prior to test. Both the input and output quills turned smoothly. The wear and backlash patterns on both the input and output gear teeth are shown in figure 40. One output gear tooth had a small hole in the top. Four other teeth were pitted on the top, and another tooth had a depression on the top convex edge approximately 0.031 inch from the outboard end. The gearbox, however, was considered serviceable for testing. After accumulating 1211.4 hours, the gearbox was again inspected. The wear pattern on the concave (load) side of the input gear had not changed since the 1071-hour inspection; however, the backlash pattern on the convex side had enlarged substantially (figure 41). The wear and backlash patterns on the output gear teeth had not changed. The hole in the top of one of the teeth and the pitting on the top of the other four teeth were still present but had not changed. The depression on the top convex edge of one tooth (observed at the 1071-hour inspection) had worn smooth and appeared to be a scuff mark. The output quill bearings rotated smoothly; however, the input quill bearings had a rough spot when rotated. Oil analysis had shown a slight rise in iron prior to the 1211.4-hour inspection; however, neither the level nor the rate of increase of iron was considered significant. The gearbox was reassembled and flushed with fresh oil. Flushing the gearbox eliminated the roughness. The flushed oil was filtered, and the sediment was microscopically examined. No metal particles were observed. The gearbox was considered serviceable for further testing and was reinstalled. After accumulating 1307.4 hours, the gearbox was again inspected. No change in the wear or backlash patterns had occurred since the 1211.4-hour inspection. A straight diagonal line was present on the convex (load) side of several of the output gear teeth. Dye-penetrant inspection revealed no crack. The line was probably produced during reassembly of the gearbox after the 1211.4-hour inspection, possibly by forcing the gears together prior to meshing. The output quill bearings turned smoothly; however, a slight roughness was detectable in the input quill. The roughness was not of such a degree as to affect the serviceability of the gearbox; therefore, the component was considered serviceable after accumulating 1307.4 hours.

Figure 36. Convex side of input gear teeth.  
(42-degree gearbox, S/N B13-1277, 1071.0  
operating hours.)

Figure 37. Concave side of input gear teeth.  
(42-degree gearbox, S/N B13-1277, 1071.0  
operating hours.)

Figure 38. Concave side of output gear teeth.  
(42-degree gearbox, S/N B13-1277, 1071.0  
operating hours.)

Figure 39. Convex side of output gear teeth.  
(42-degree gearbox, S/N B13-1277, 1071.0  
operating hours.)

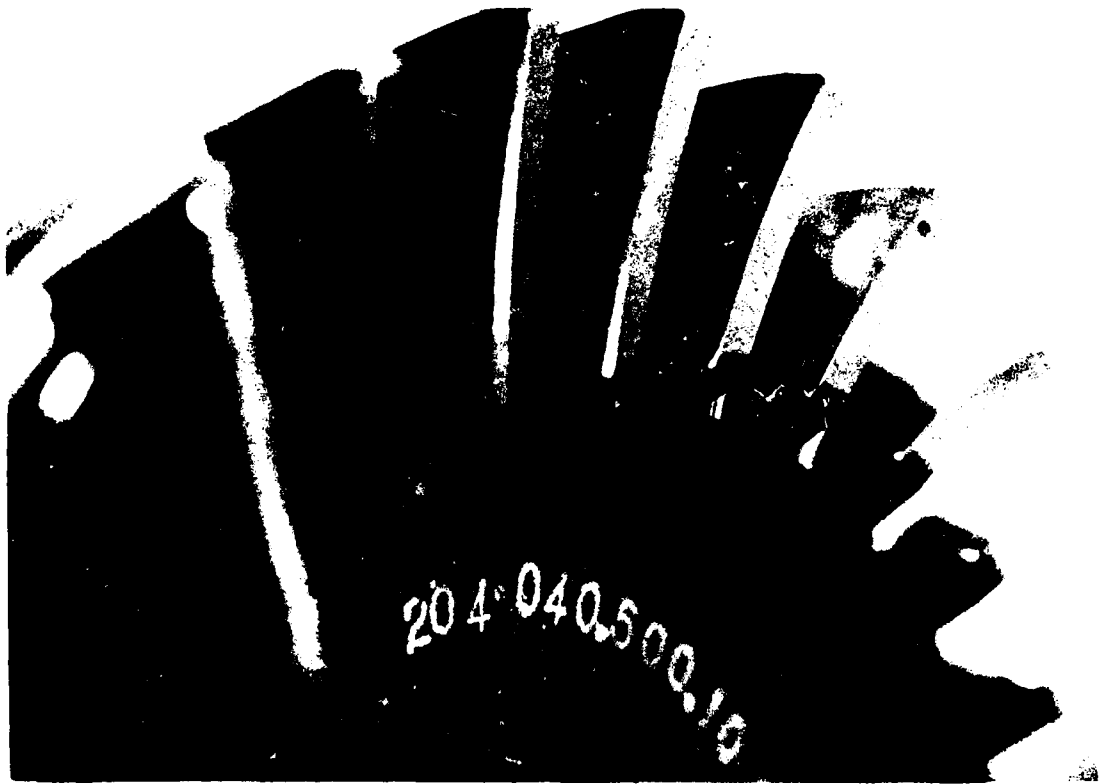
f. S/N B13-2931. This gearbox was previously operated 1101.9 hours on UH-1B/540, S/N 64-14104, during the Phase F testing at the USAAVNTBD. The gearbox was inspected prior to test and the gear teeth were photographed (figures 42 and 43). The wear and backlash patterns present at 1101.9 hours are shown in figure 44. The bearings were somewhat tight in rotation; however, no roughness was

Figure 42. Concave side of input gear teeth.  
(42-degree gearbox, S/N B13-2931, 1101.9  
operating hours.)

Figure 43. Convex side of output gear teeth.  
(42-degree gearbox, S/N B13-2931, 1101.9  
operating hours.)

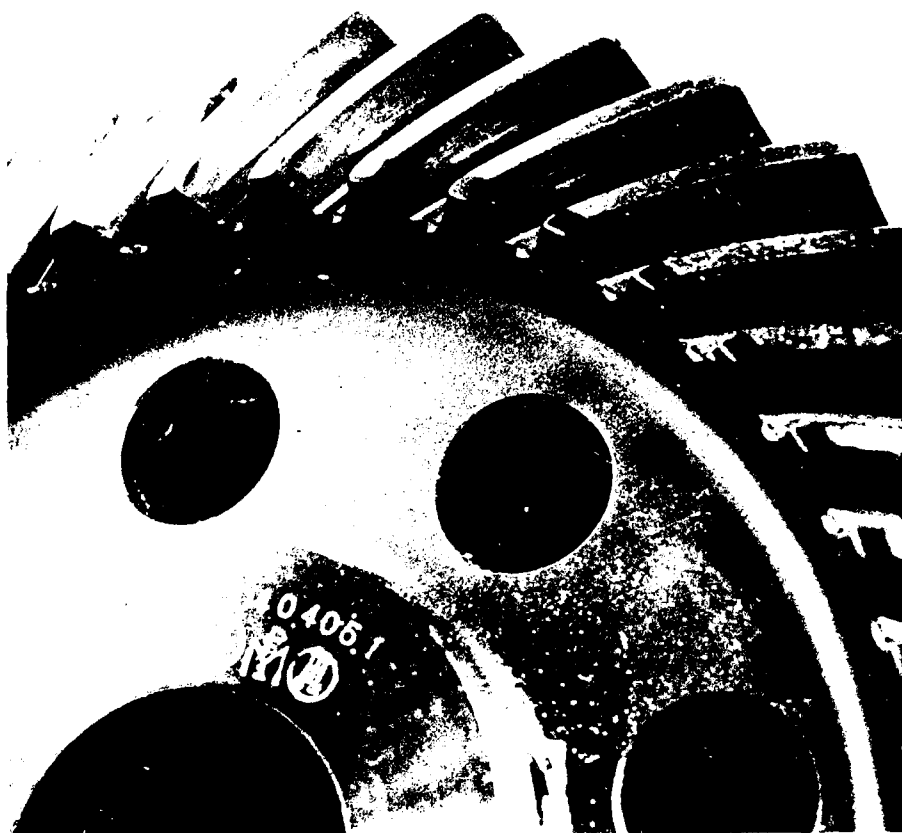
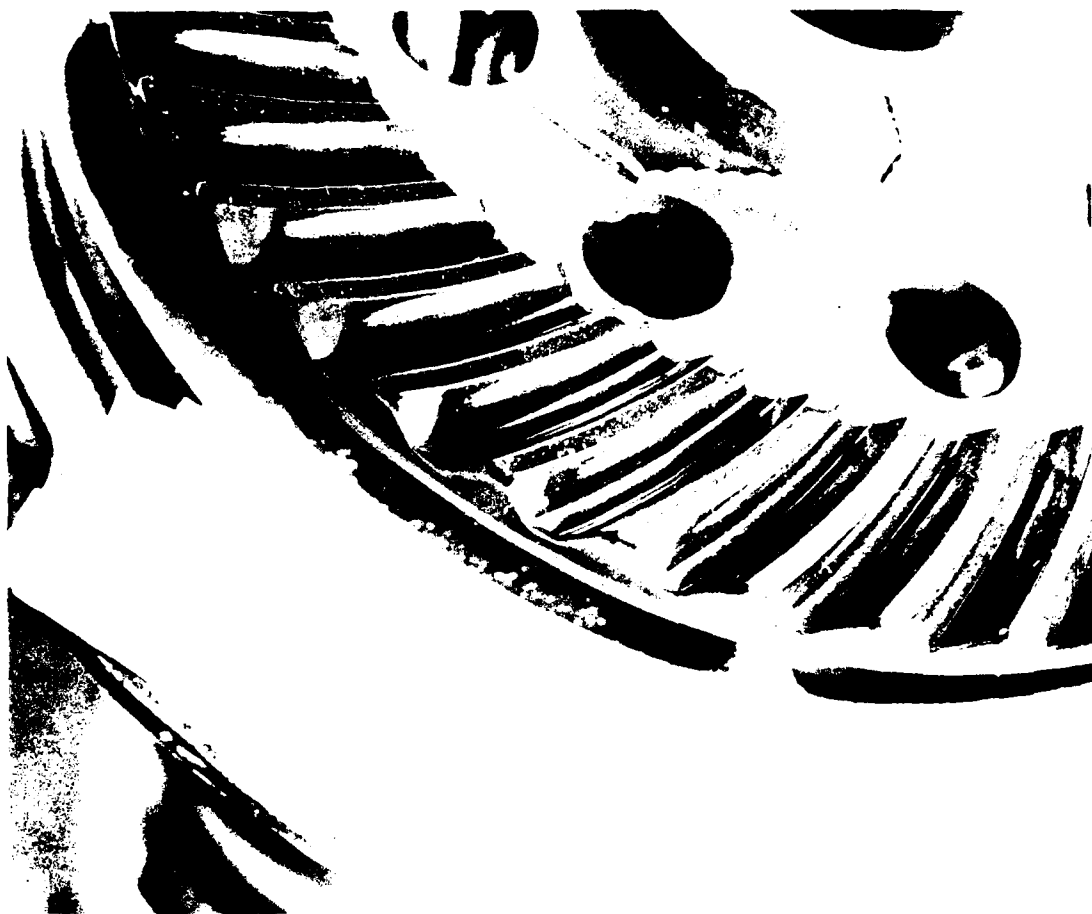
a. S/N B13-1194. This gearbox had operated 1144.0 hours in RVN. The gearbox was inspected and photographed (figures 46, 47, 48, and 49). Gear wear and backlash patterns are shown in figure 50. Both the input and output quills turned smoothly; therefore, the gearbox was considered suitable for testing. After accumulating 1171.3 hours, the chip detector light illuminated. Visual inspection of the magnetic plug confirmed the presence of metal particles. Disassembly inspection revealed that the wear pattern now extended off the top edge on the inboard end of the input gear teeth on the concave side (figure 51). The bearings in both quills rotated smoothly. The metal particles may have originated from the extended wear area on the concave side of the input gear or from loose material remaining after drilling of a magnetic plug safety wire hole. The gearbox was flushed with fresh oil and reinstalled for further testing. After one hour and forty-five minutes, at 1173.0 component hours, the chip detector light again illuminated; however, no chips were found on the plug. The gearbox was again disassembled and inspected. No change in the wear or backlash pattern on either gear was evident and the bearings in both quills rotated smoothly. In general, no deterioration was evident. Oil analysis had indicated a small increase in iron and copper between 1171.3 and 1173.0 hours. The gearbox was carried to USAADMAC for a test-cell run and complete disassembly inspection. Four and one-half hours of test-cell run were accomplished at the following speeds and torque loads:

Figure 46. Convex side of input gear teeth.  
(90-degree gearbox, S/N B13-1194, 1144.0  
operating hours.)

Figure 47. Concave side of input gear teeth.  
(90-degree gearbox, S/N B13-1194, 1144.0  
operating hours.)

Figure 48. Concave side of output gear teeth.  
(90-degree gearbox, S/N B13-1194, 1144.0  
operating hours.)

Figure 49. Convex side of output gear teeth.  
(90-degree gearbox, S/N B13-1194, 1144.6  
operating hours.)
